**POST-REMEDIATION MOLD ASSESSMENT
AND CLEARANCE REPORT**

**Marcus High School
ROTC Hallway
5707 Morriss Road
Flower Mound, Texas**

August 17, 2015
LISD PO No. 91538989-00
Apex Project No. 7250115212

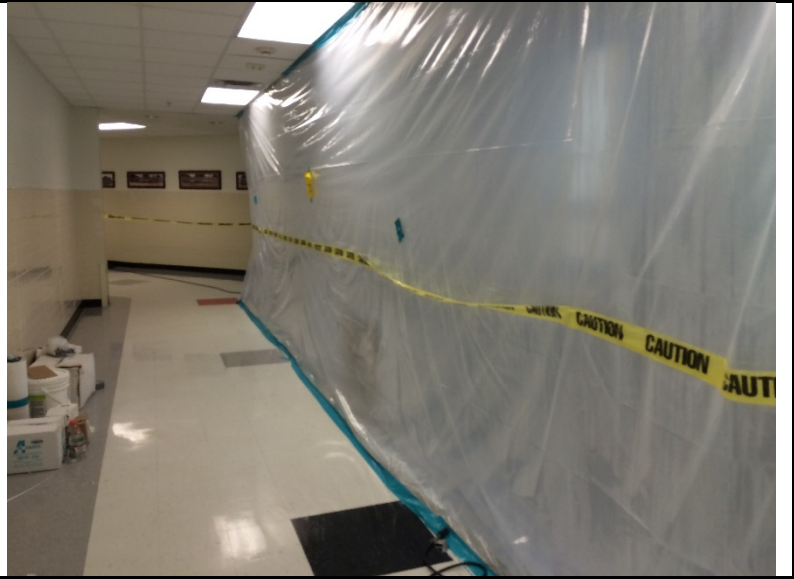
Photograph 1

View of containment.

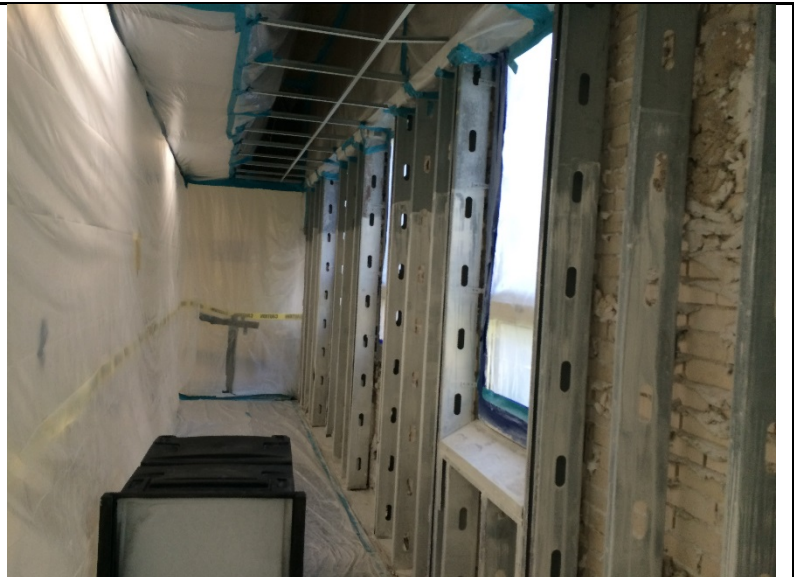
Photograph 2

View of remediated area.

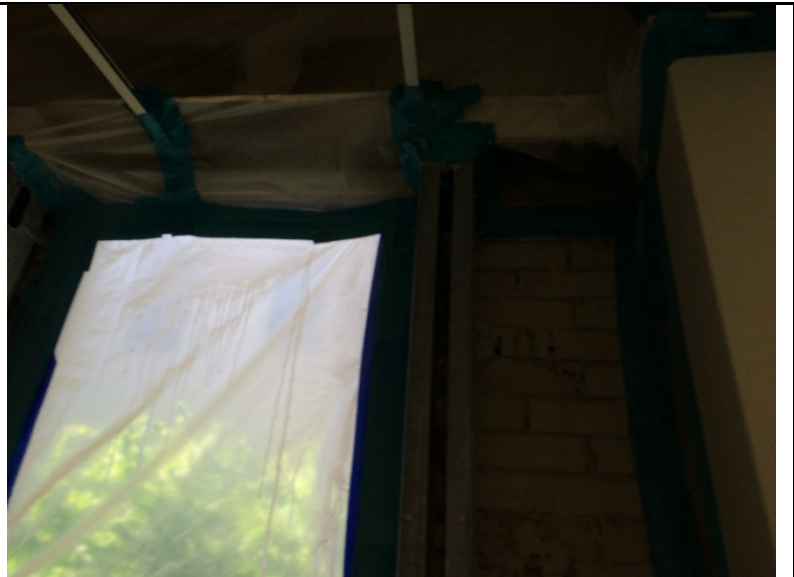
Photograph 3

View of remediated area.

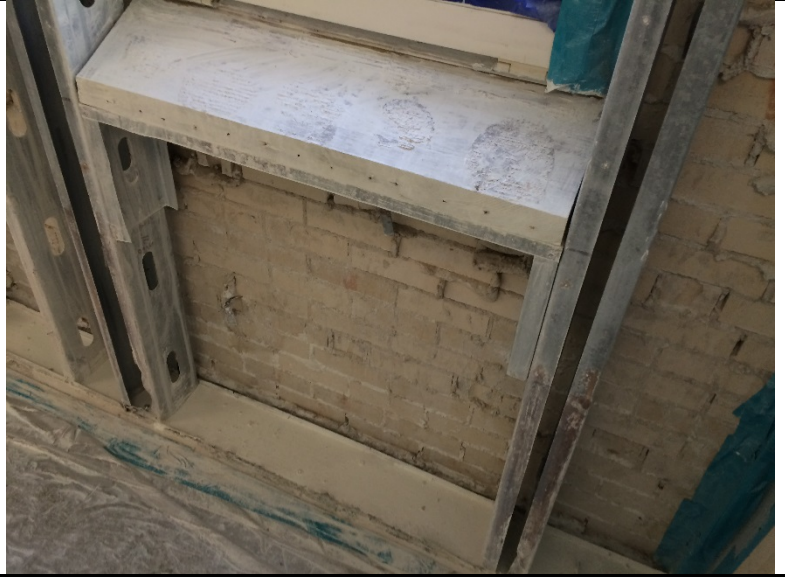
Photograph 4

View of remediated area.
