**POST-REMEDIATION MOLD ASSESSMENT
AND CLEARANCE REPORT**

**West Side Aquatic Center
Boy's Shower – Room B108
1750 Duncan Lane
Lewisville, Texas**

November 30, 2016
Apex Project No. 72501027036

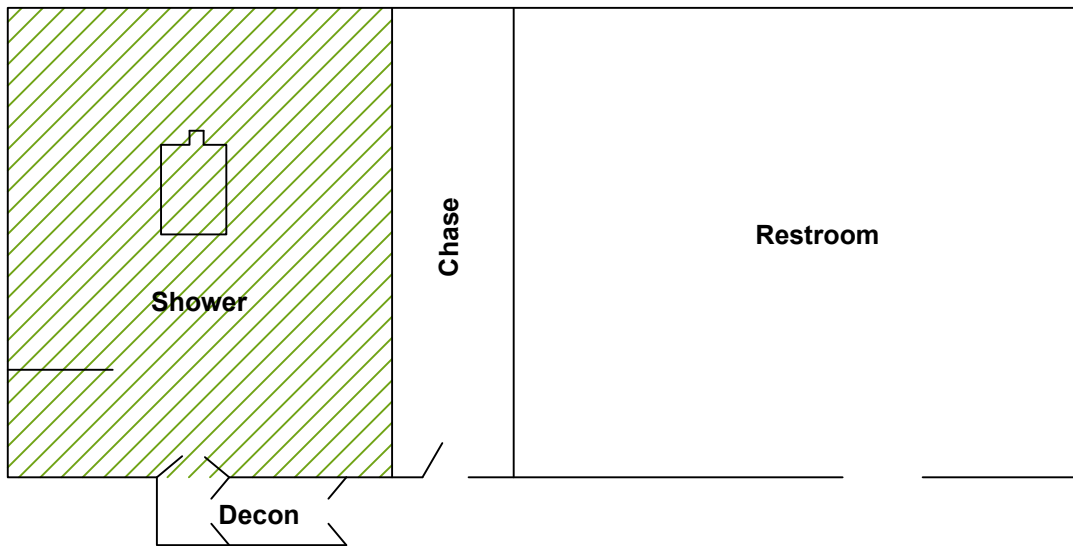
FIGURE 1
Fungal Growth Location Map

Based on the information provided by the client, the site consists of fungal growth associated with the sheetrock ceiling within the boy’s shower – room B108 area at the West Side Aquatic Center.

Based upon the documentation provided to Apex (copy attached in Appendix F), the source of moisture was identified as: moisture due to a lack of exhaust fan.

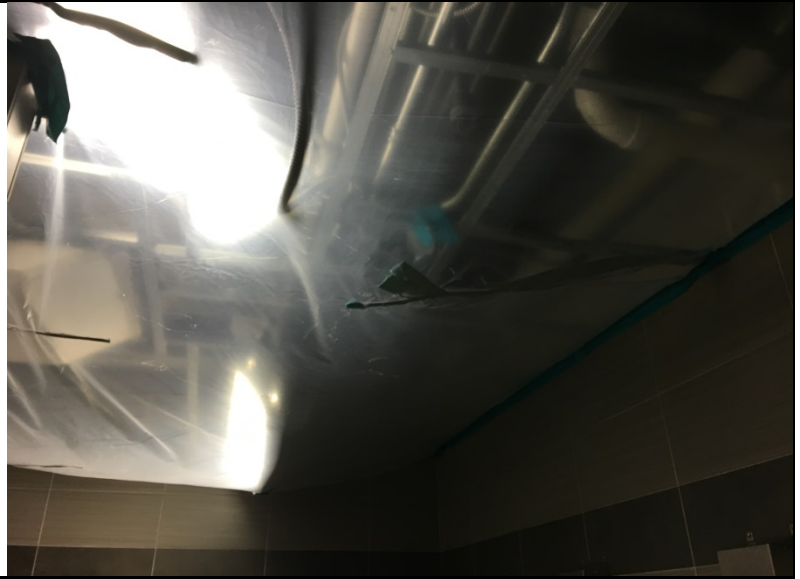
Photograph 1

View of remediated area.

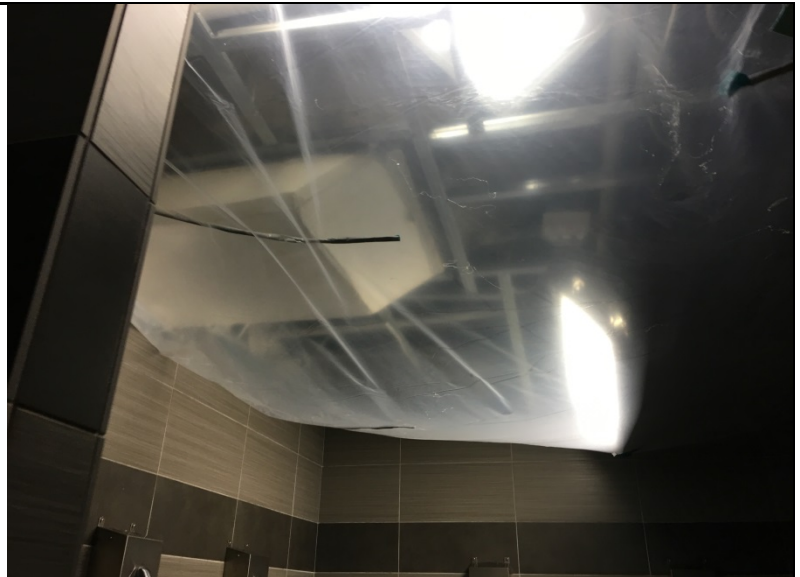
Photograph 2

View of remediated area.
