**POST-REMEDATION MOLD ASSESSMENT  
AND CLEARANCE REPORT**

**Bolin Administrative Center  
Suite 105  
1585 W. Main Street  
Lewisville, Texas**

May 30, 2017  
Apex Project No. 72501027079

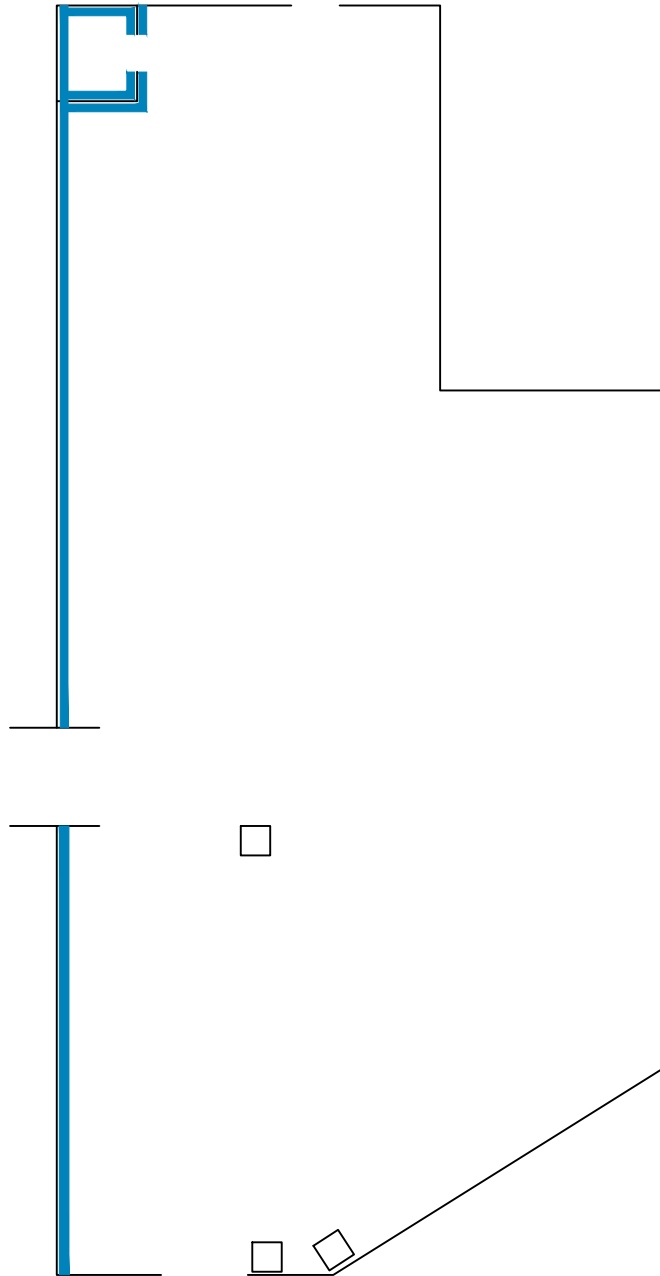
**FIGURE 1**  
**Fungal Growth Location Map**  
**Suite 105**

Based on the information provided by the CLIENT, the site consists of fungal growth associated with the sheetrock walls within suite 105 of the Bolin Administrative Center

Based upon the documentation provided to Apex (copy attached in Appendix F), the source of moisture was identified as: water used in the animal shelter bath of the previous tenant.

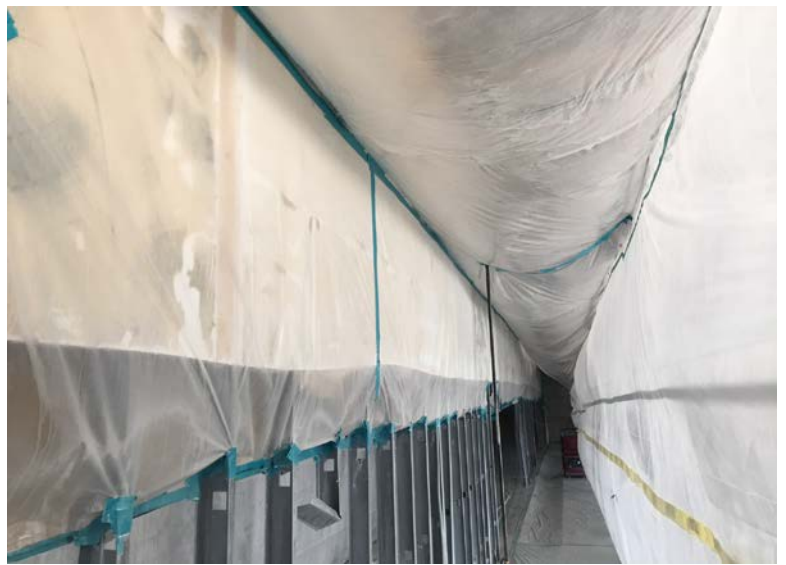
**Photograph 1**

View of remediated area.

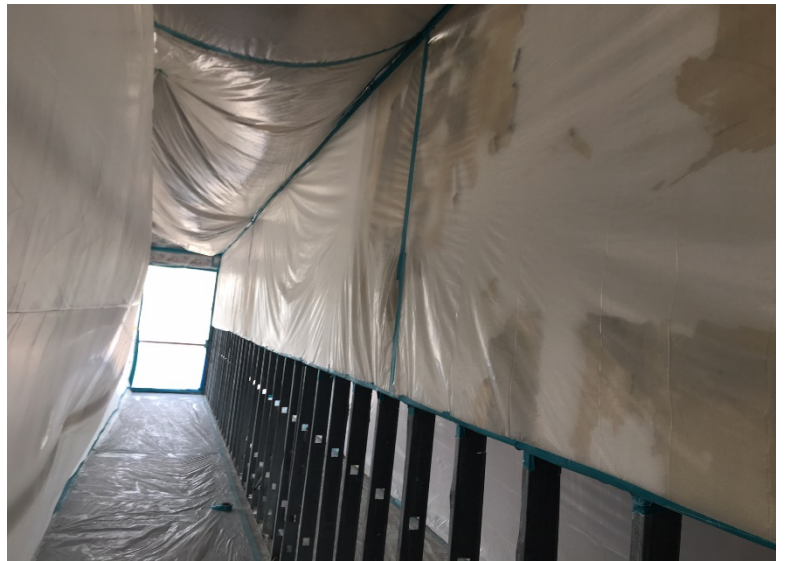
**Photograph 2**

View of remediated area.

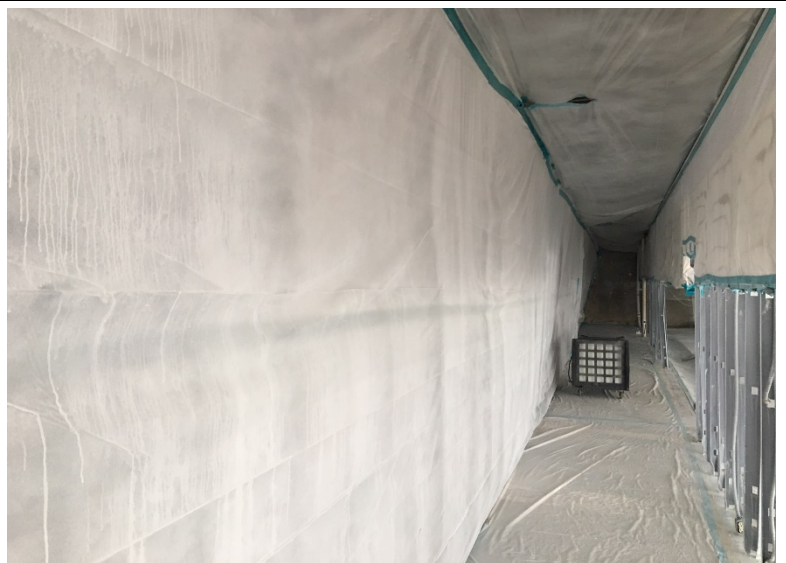
**Photograph 3**

View of remediated area.
