**POST-REMEDATION MOLD ASSESSMENT
AND CLEARANCE REPORT**

**BB Owen Elementary School
Library
5640 Squires
The Colony, Texas**

May 20, 2013
Project No. 0113H113

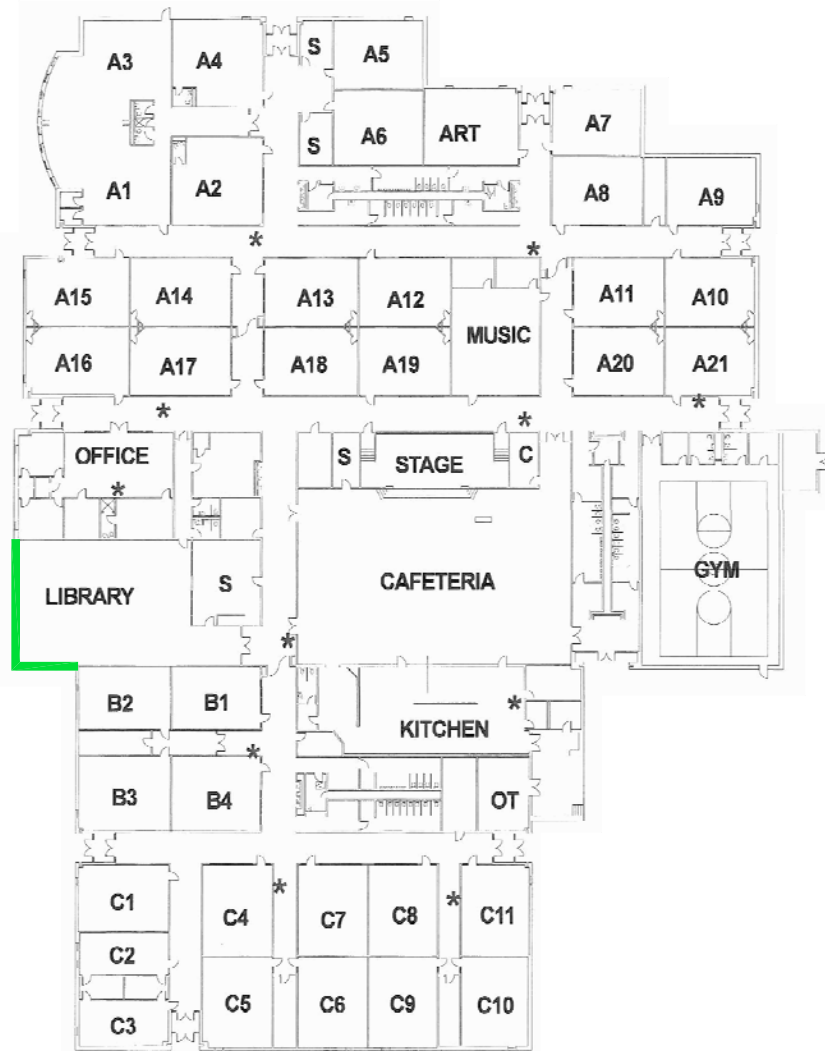
Figure 1
Fungal Growth
Location Map

DRAWING NOT TO SCALE
 FUNGAL GROWTH LOCATIONS ARE APPROXIMATE

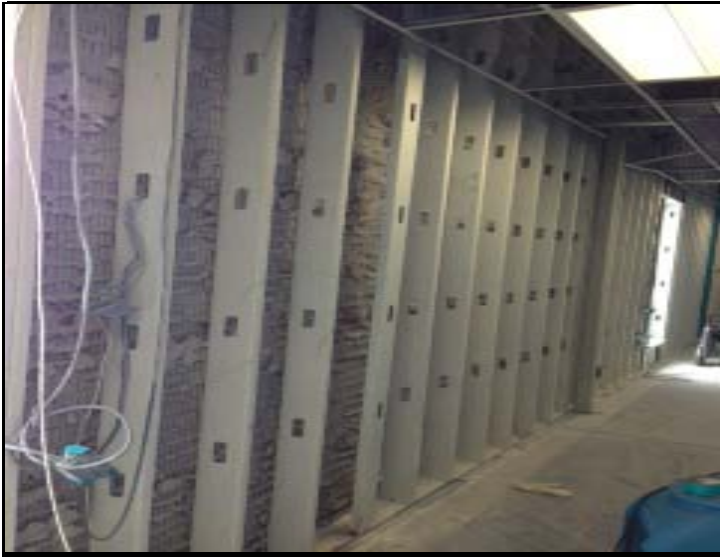
1.) View of remediated areas.

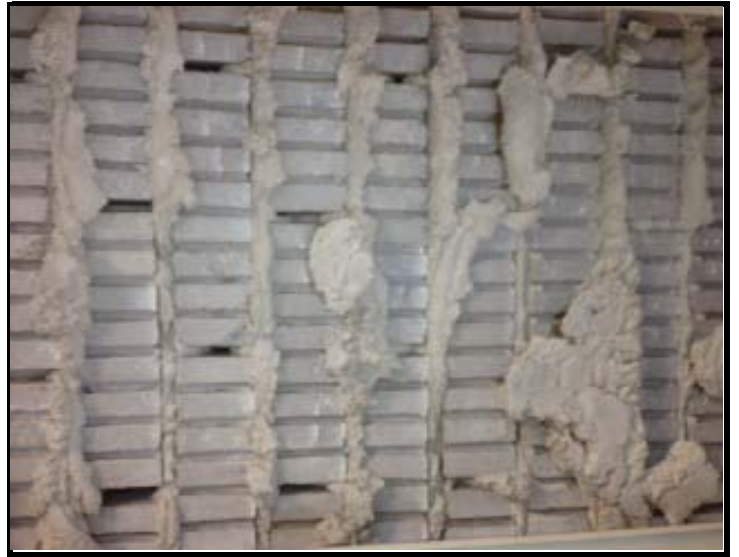
2.) View of remediated areas.

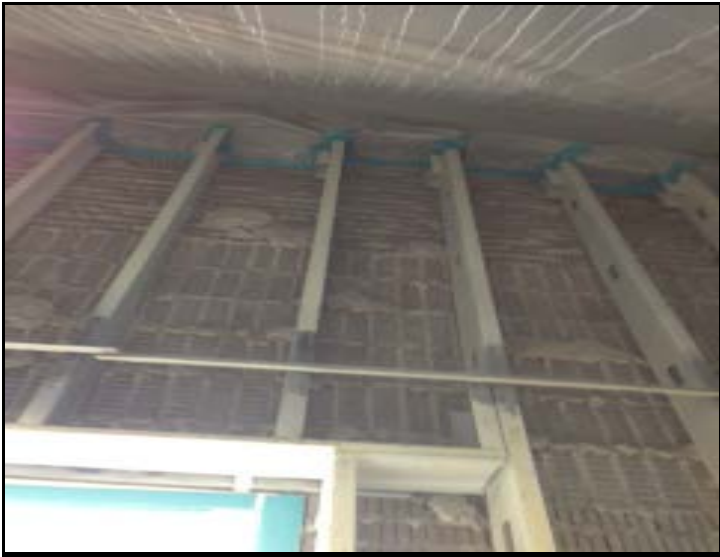
3.) View of remediated areas.

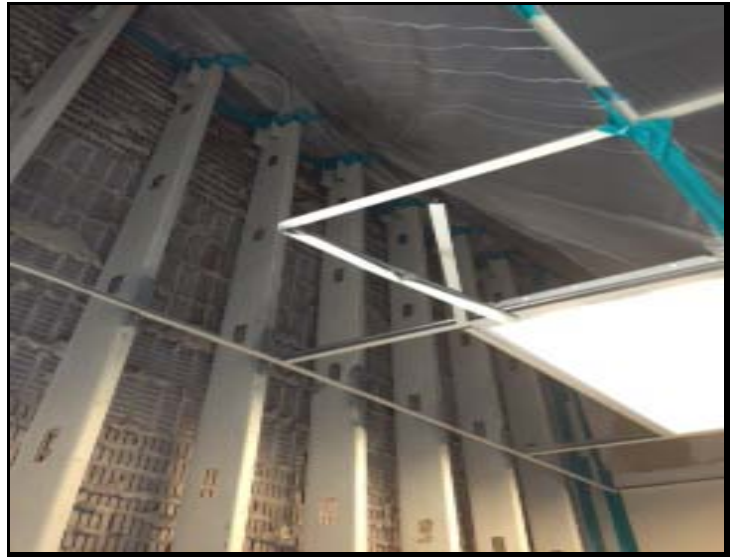
4.) View of remediated areas.

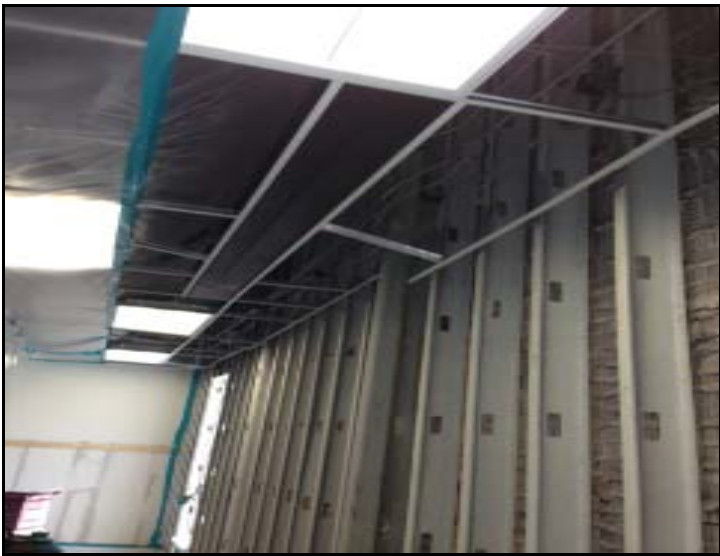
5.) View of remediated areas.
