Re: Limited Mold Assessment
Ethridge Elementary School - Rooms A16, A17, Art Room
6001 Ethridge Drive
The Colony, TX 75056
Ensolum Project No. 01A1288187

1.0 INTRODUCTION

APPENDIX A

ANALYTICAL RESULTS

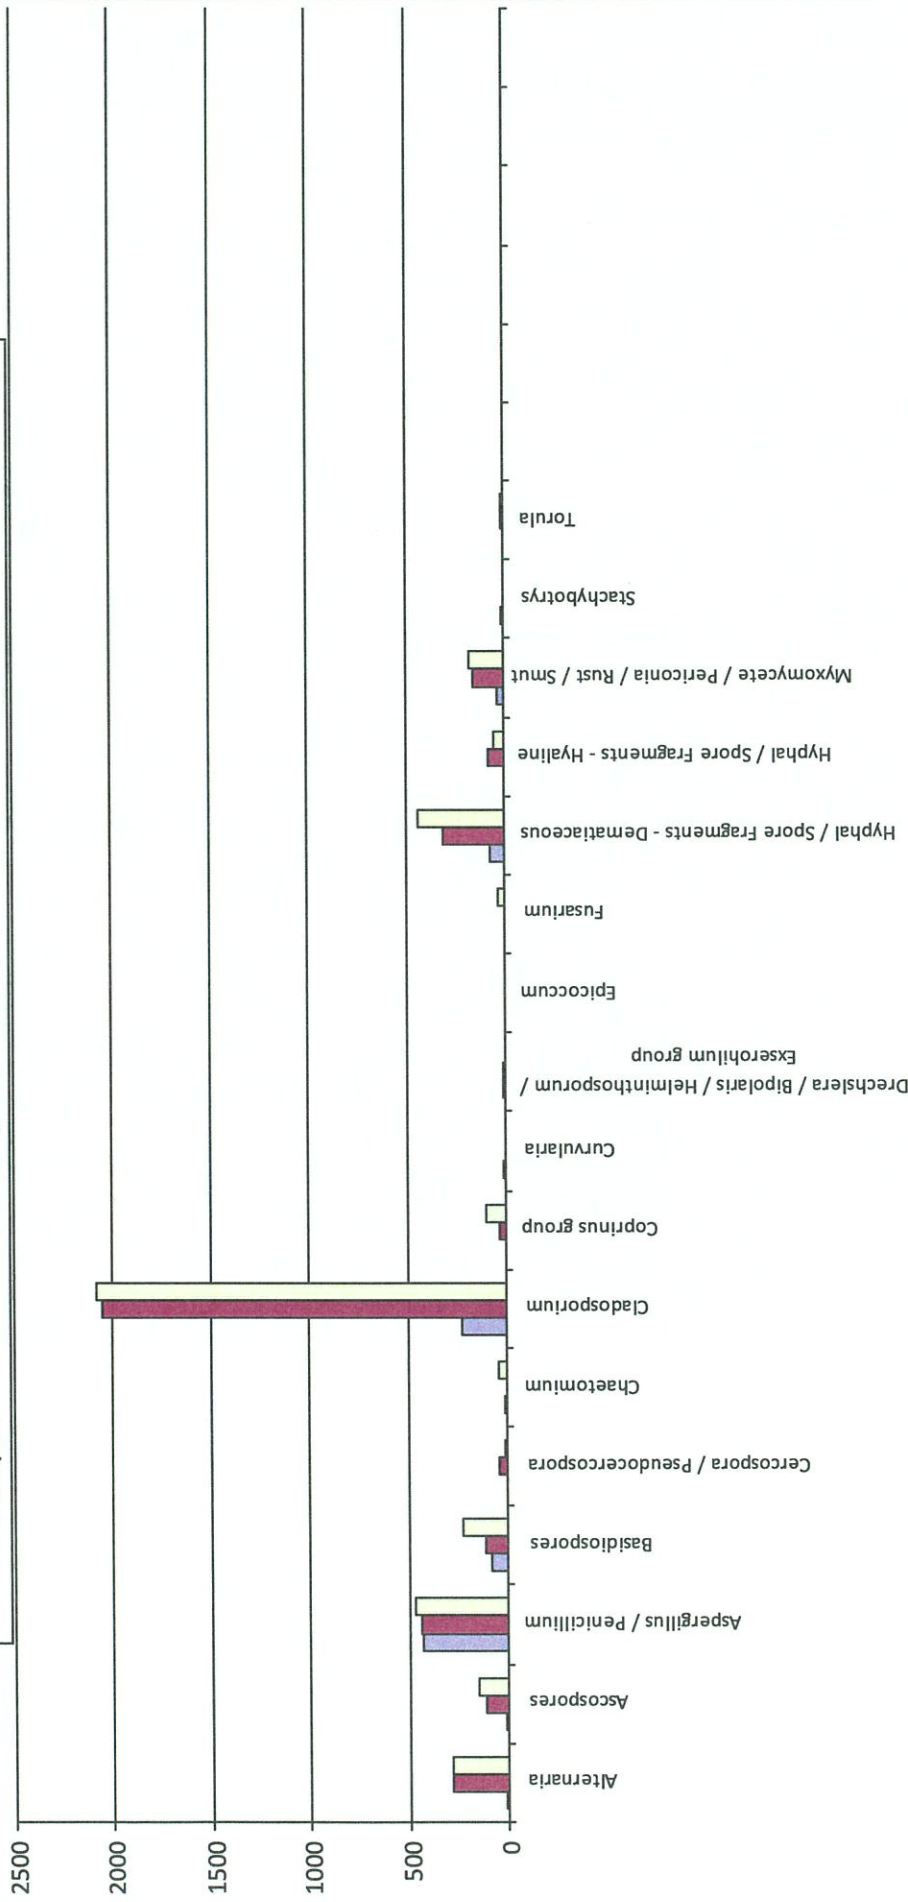
Classroom A16

Room A16 - Two (2) types of mold spores were reported at higher concentrations inside the classroom as compared to the exterior of the building. *Stachybotrys* and *Curvularia* was reported as 13 spores/m³ while no spores were identified in the exterior samples.

Ensolum recommends that the wall containing elevated moisture reading be removed. In addition, the rooms should be cleaned and addition testing performed.

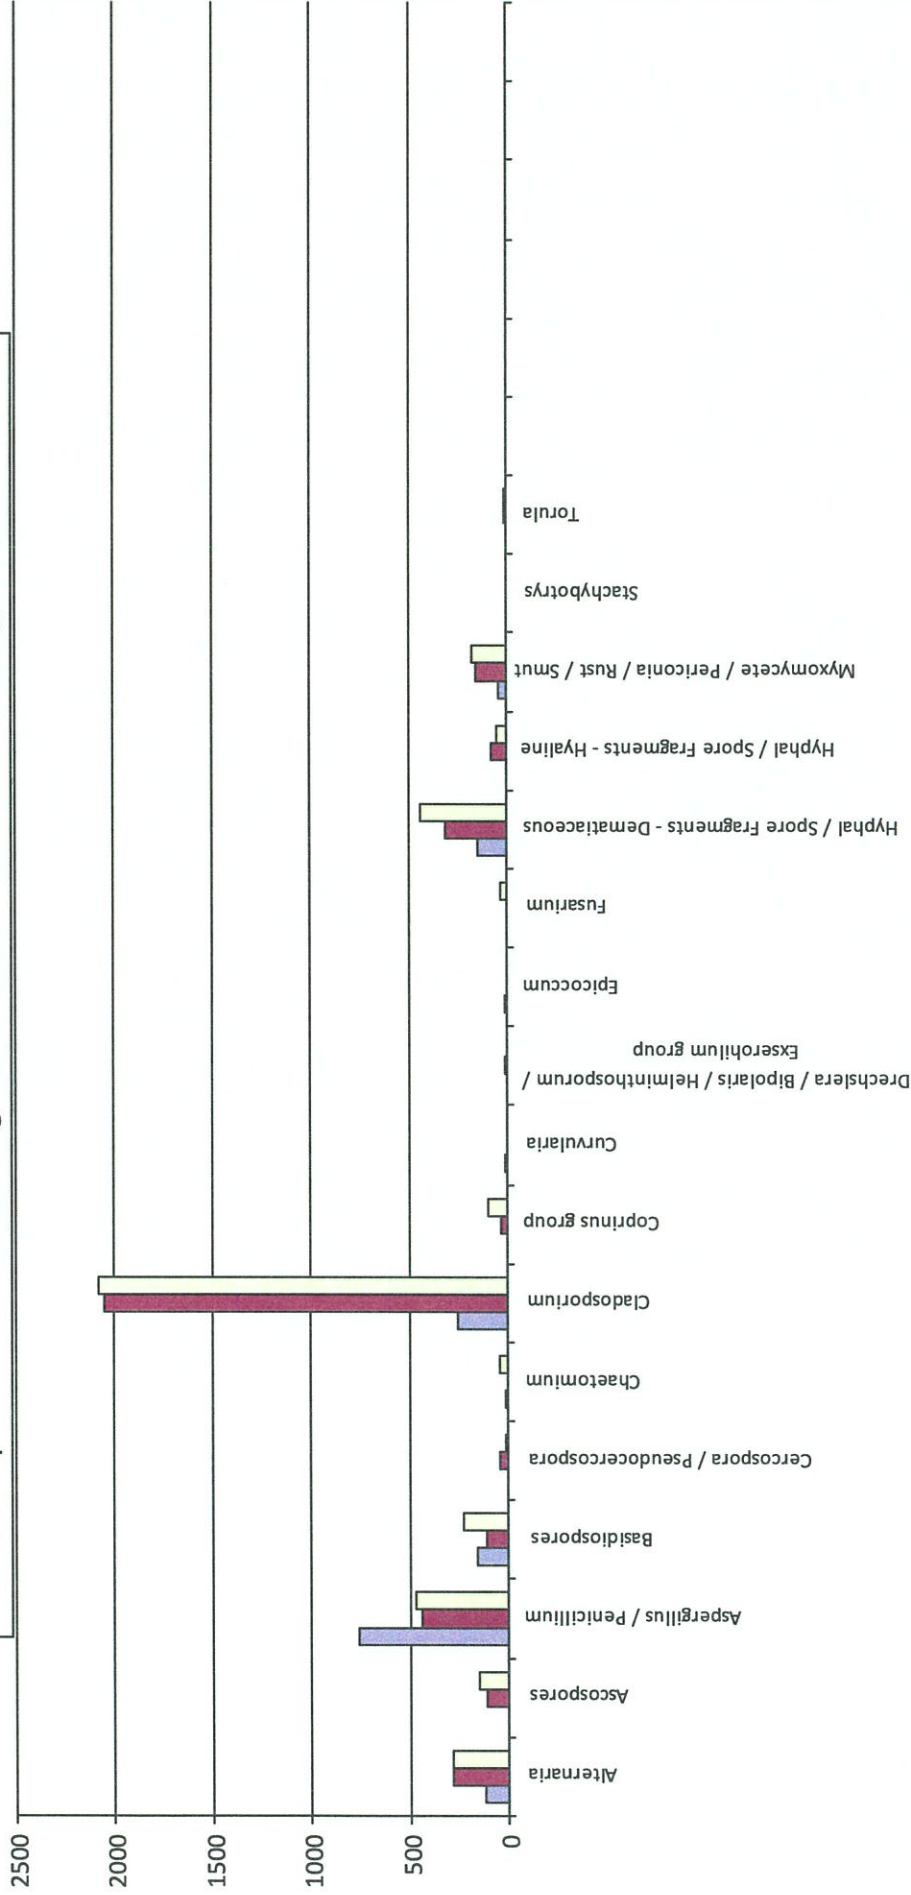
Classroom A17

Room A17 - Two (2) types of mold spores were reported at higher concentrations inside the classroom as compared to the exterior of the building. *Aspergillus/Penicillium* was reported as 760 spores/m³ while exterior concentrations were reported at 467 spores/m³. *Epicoccum* was reported as 13 spores/m³ while no spores were identified in the exterior samples.

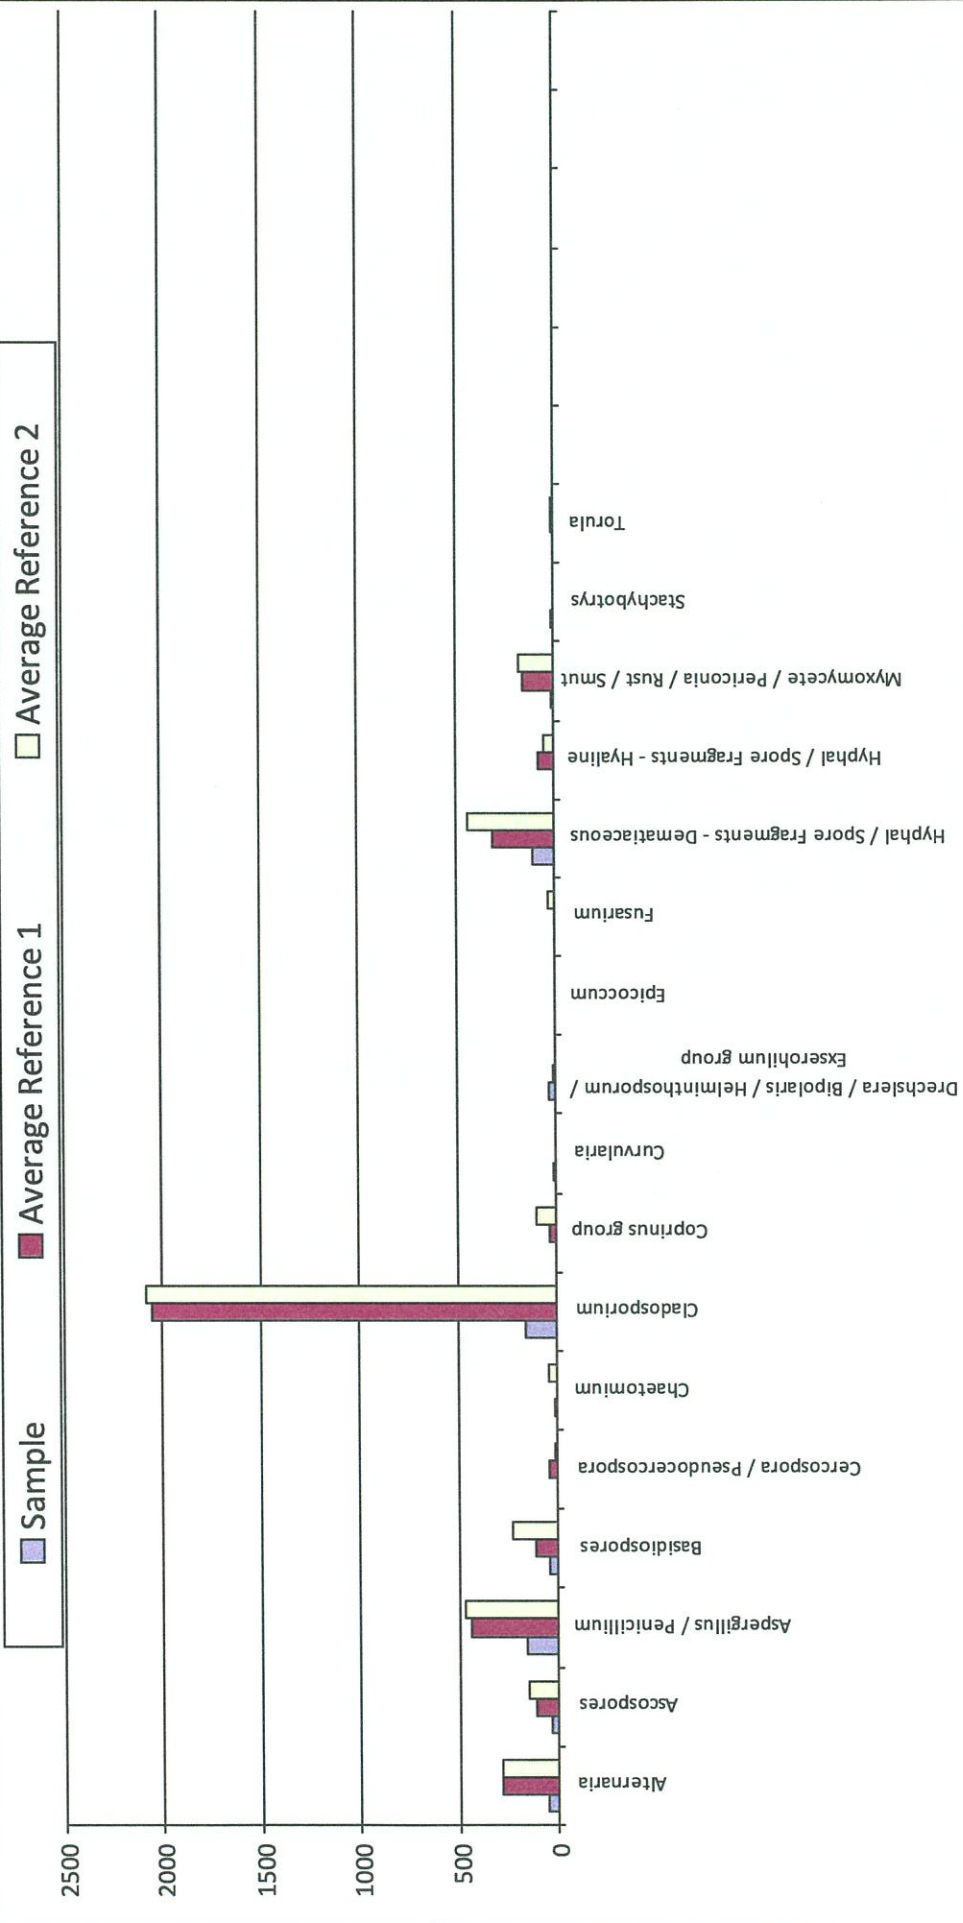
Art Room - Two (2) types of mold spores were reported at higher concentrations inside the classroom as compared to the exterior of the building. *Stachybotrys* 13 spores/m³ and *Curvularia* was reported as 13 spores/m³ while no spores were identified in the exterior samples.
