SUBJECT: Central ES - IAQ - Air Test Results - Room 523

Limited Mold Assessment
Central Elementary School – Room 523
400 High School Street
Lewisville, Texas
Ensolum Project No. 01A.1288.023

1.0 INTRODUCTION

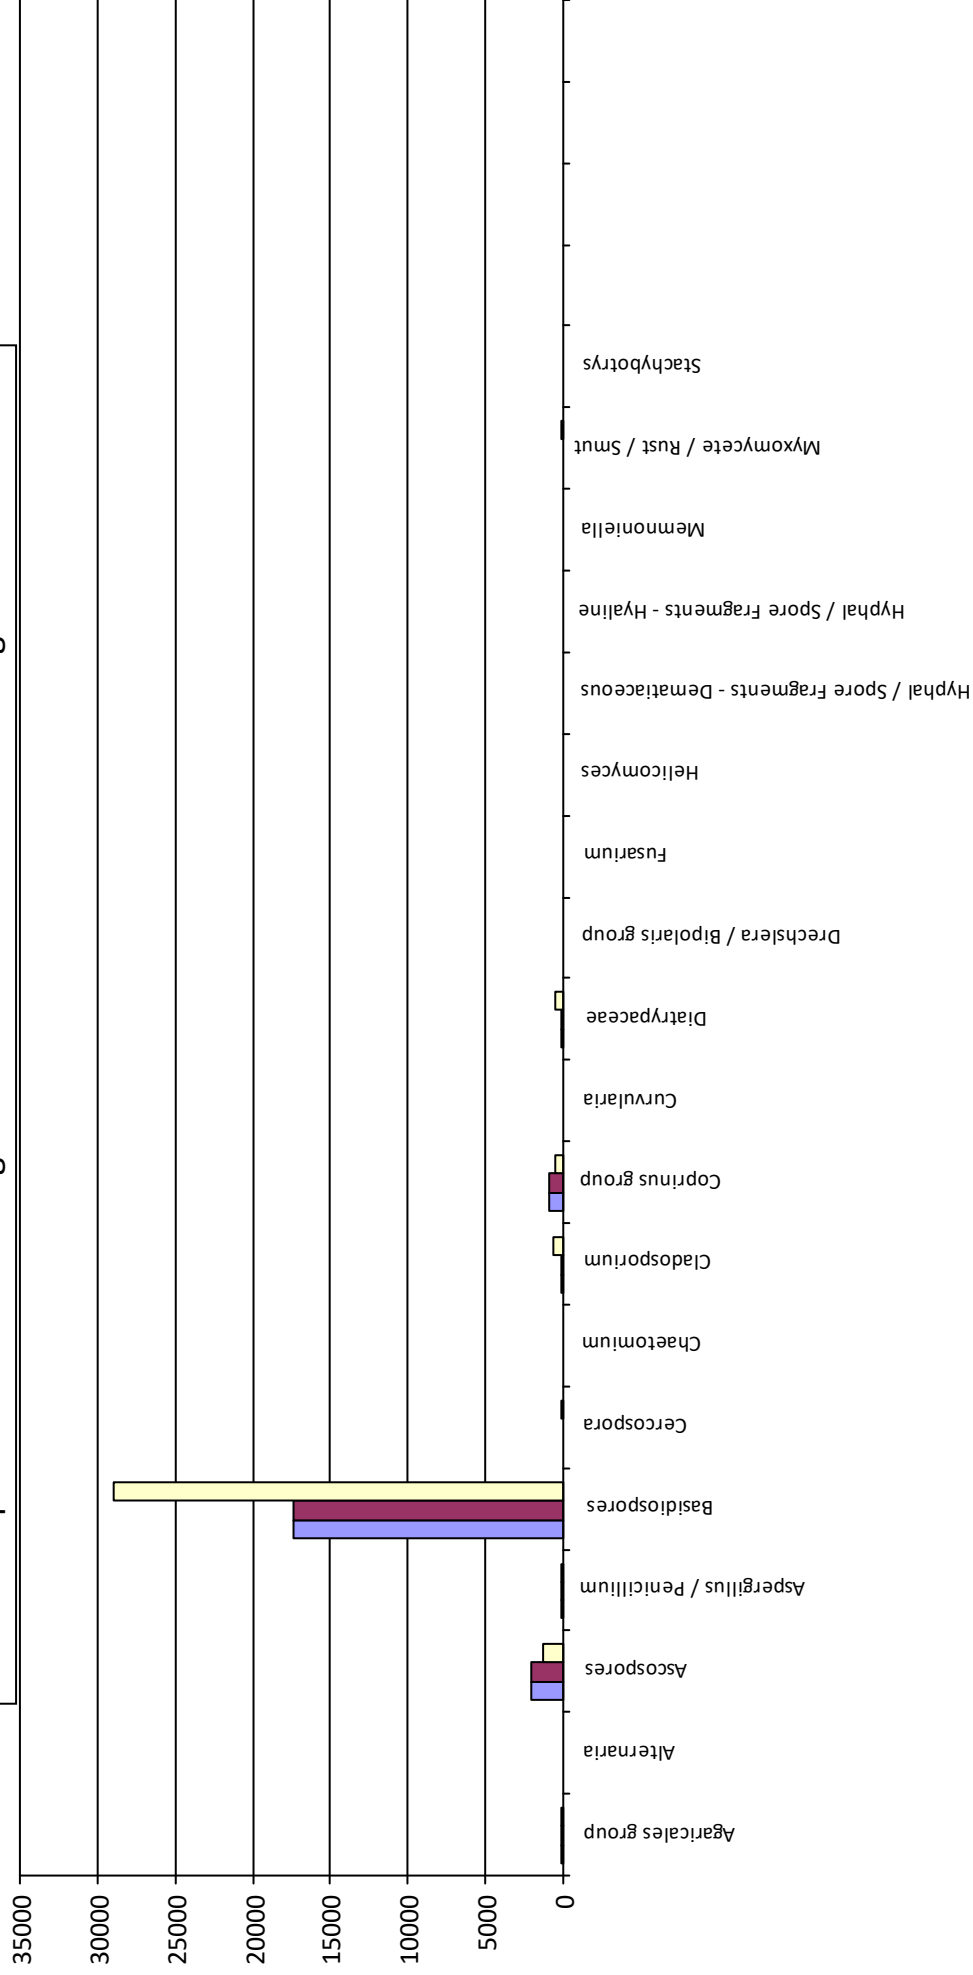
Average Reference 1 = Outside Southwest Exit by Gym

Average Reference 2 = Outside Front Entry
