SUBJECT: Valley Ridge ES - IAQ - Air Test Results - Rooms 136 & 142

Limited Mold Assessment
Valley Ridge Elementary School – Room 136 and Classroom 142
1604 North Garden Ridge Blvd.
Lewisville, Texas
Ensolum Project No. 01A.1288.028

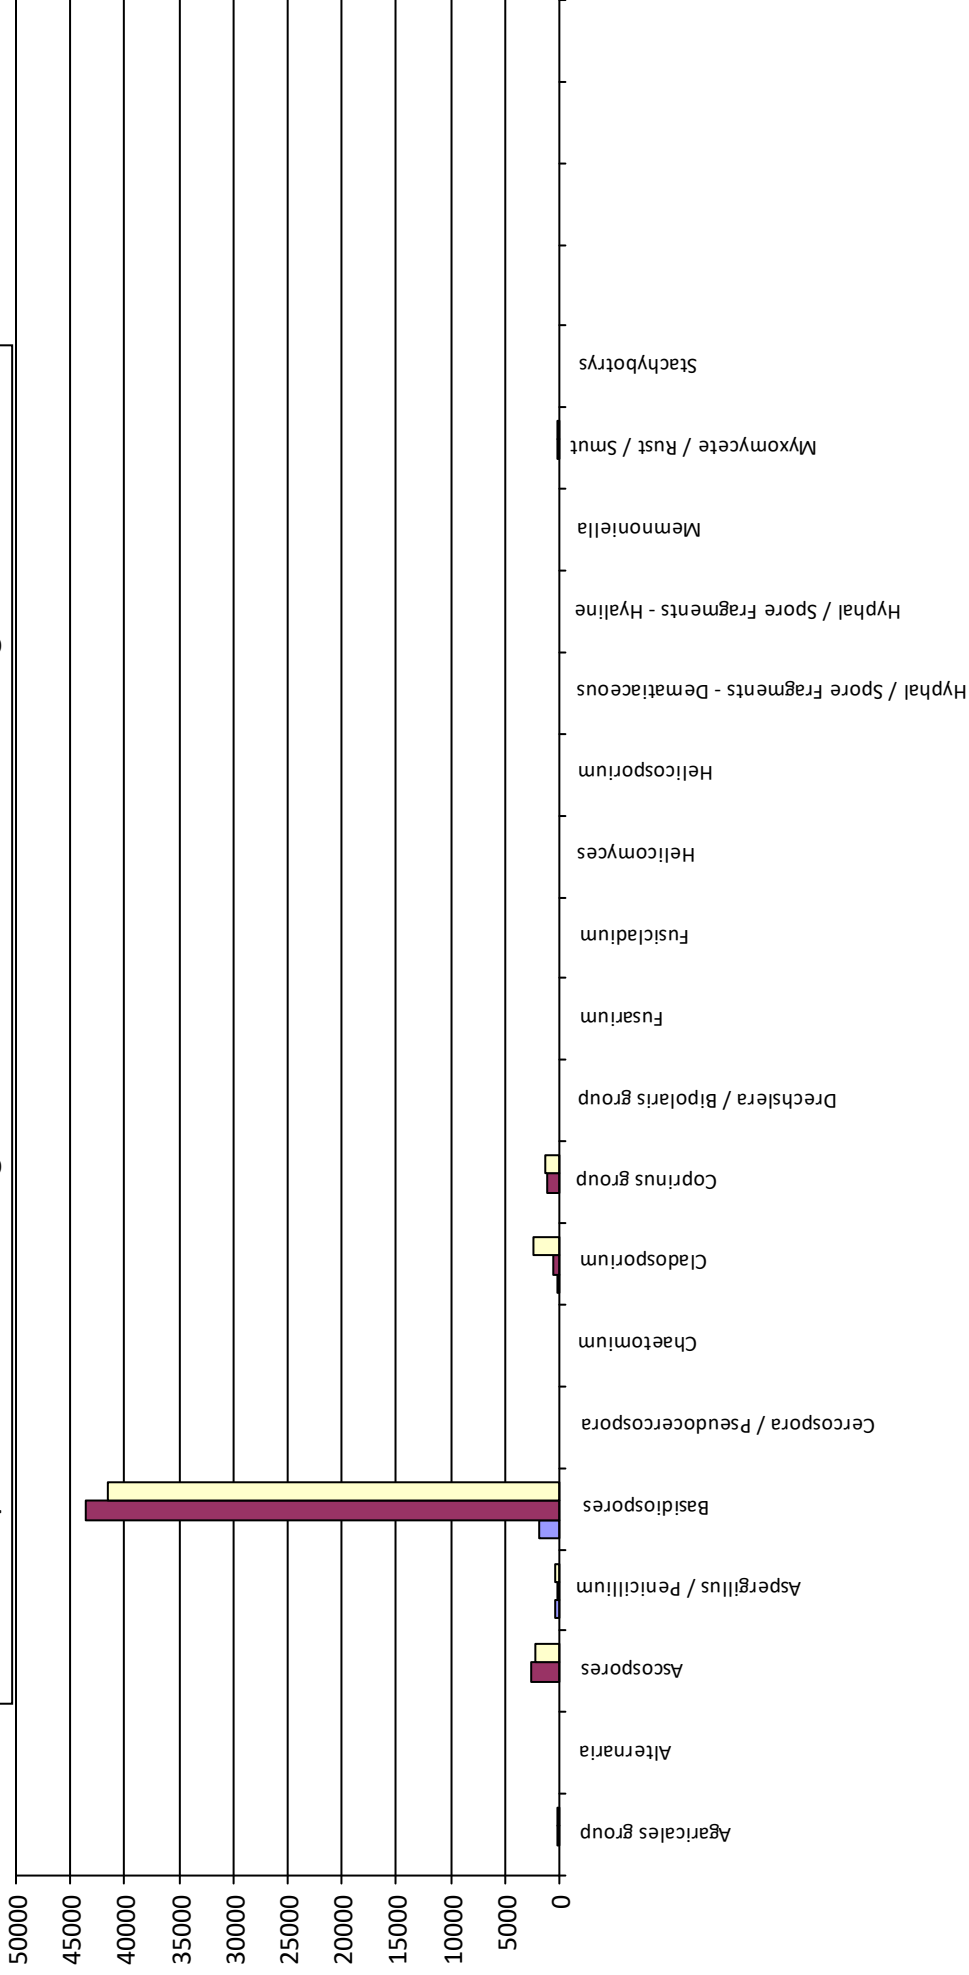
Lab Job No. 19F-06113
Report Date 05/22/2019 7:00 PM
Sample Date : 05/22/2019
Room 136

The results of the fungal air samples collected on May 22, 2019 were evaluated. The air samples collected from Classroom 136 and Classroom 142 (ST – 1 and ST – 2) yielded elevated concentrations of *Aspergillus/Penicillium* in comparison with the Outdoor samples (ST – 3 and ST – 4).

1. Water damaged vinyl wall covering within Classroom 136 shall be removed and replaced with new.
2. Water damaged carpet within Classroom 142 shall be cleaned thoroughly.
3. Once affected building materials are removed and replaced Ensolum recommends an additional air sampling in both Classrooms to verify that elevation of fungal spores and structures has been alleviated.
