April 14, 2017

Lewisville Independent School District
340 Lake Haven
Lewisville, Texas 75057
Attn: Mr. Paul Siddall

Re: Limited Mold Assessment Services
Flower Mound Elementary School
Room 102, Principal's Office &
Art Room
4101 Churchill
Flower Mound, Texas
LISD PO No. 91730030-00
Apex Project No. 725010727068

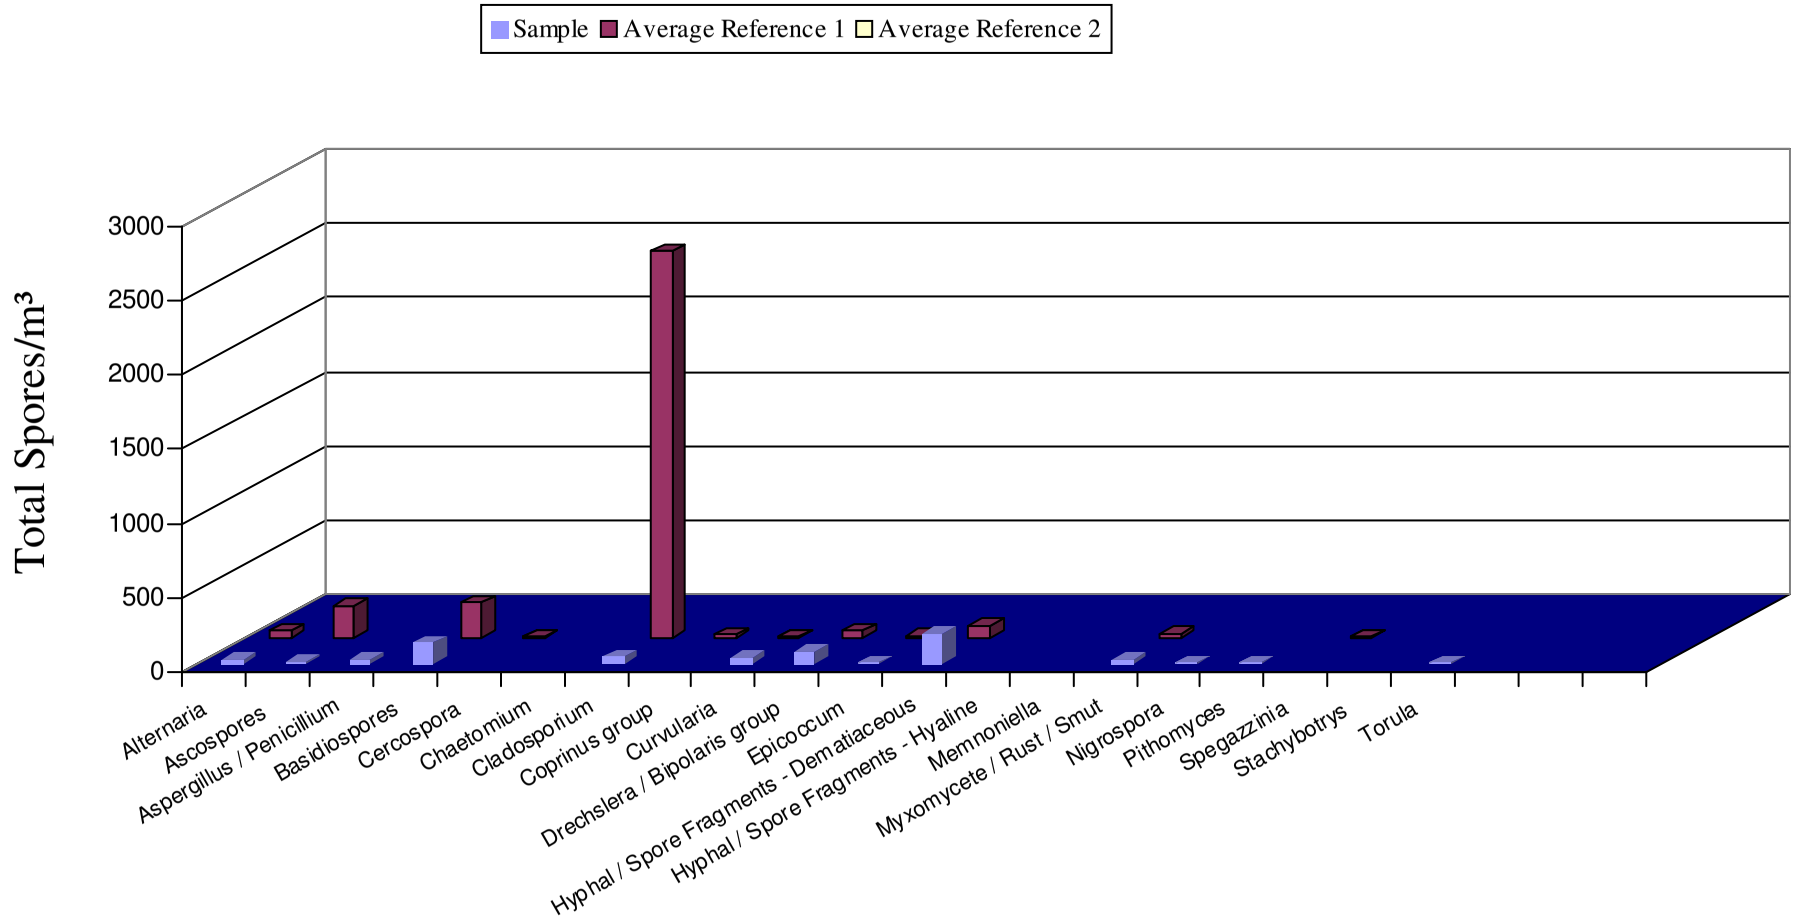
Room 102

Seven types of mold were identified at a higher concentration within the investigation area as compared to the samples collected from the exterior of the building. Air sample(s) collected within room 102 reported Hyphal/Spore Fragments - Dematiaceous as 200 counts/m^3 while exterior levels were reported as 113 counts/m^3, Drechslera/Bipolaris Group as 80 counts/m^3 while exterior levels were reported as 47 counts/m^3 and Curvulaira as 40 counts/m^3 while exterior levels were reported as 7 counts/m^3. In addition, Aspergillus/Penicillium was reported as 27 counts/m^3, Nigrospora as 7 counts/m^3, Torula as 7 counts/m^3 and Pithomyces as 7 counts/m^3 while no exterior levels were reported.

of the assessment. However, due to the high amounts of Hyphal/Spore Fragments identified in room 102, Apex recommends that the room be retested in approximately six (6) weeks.

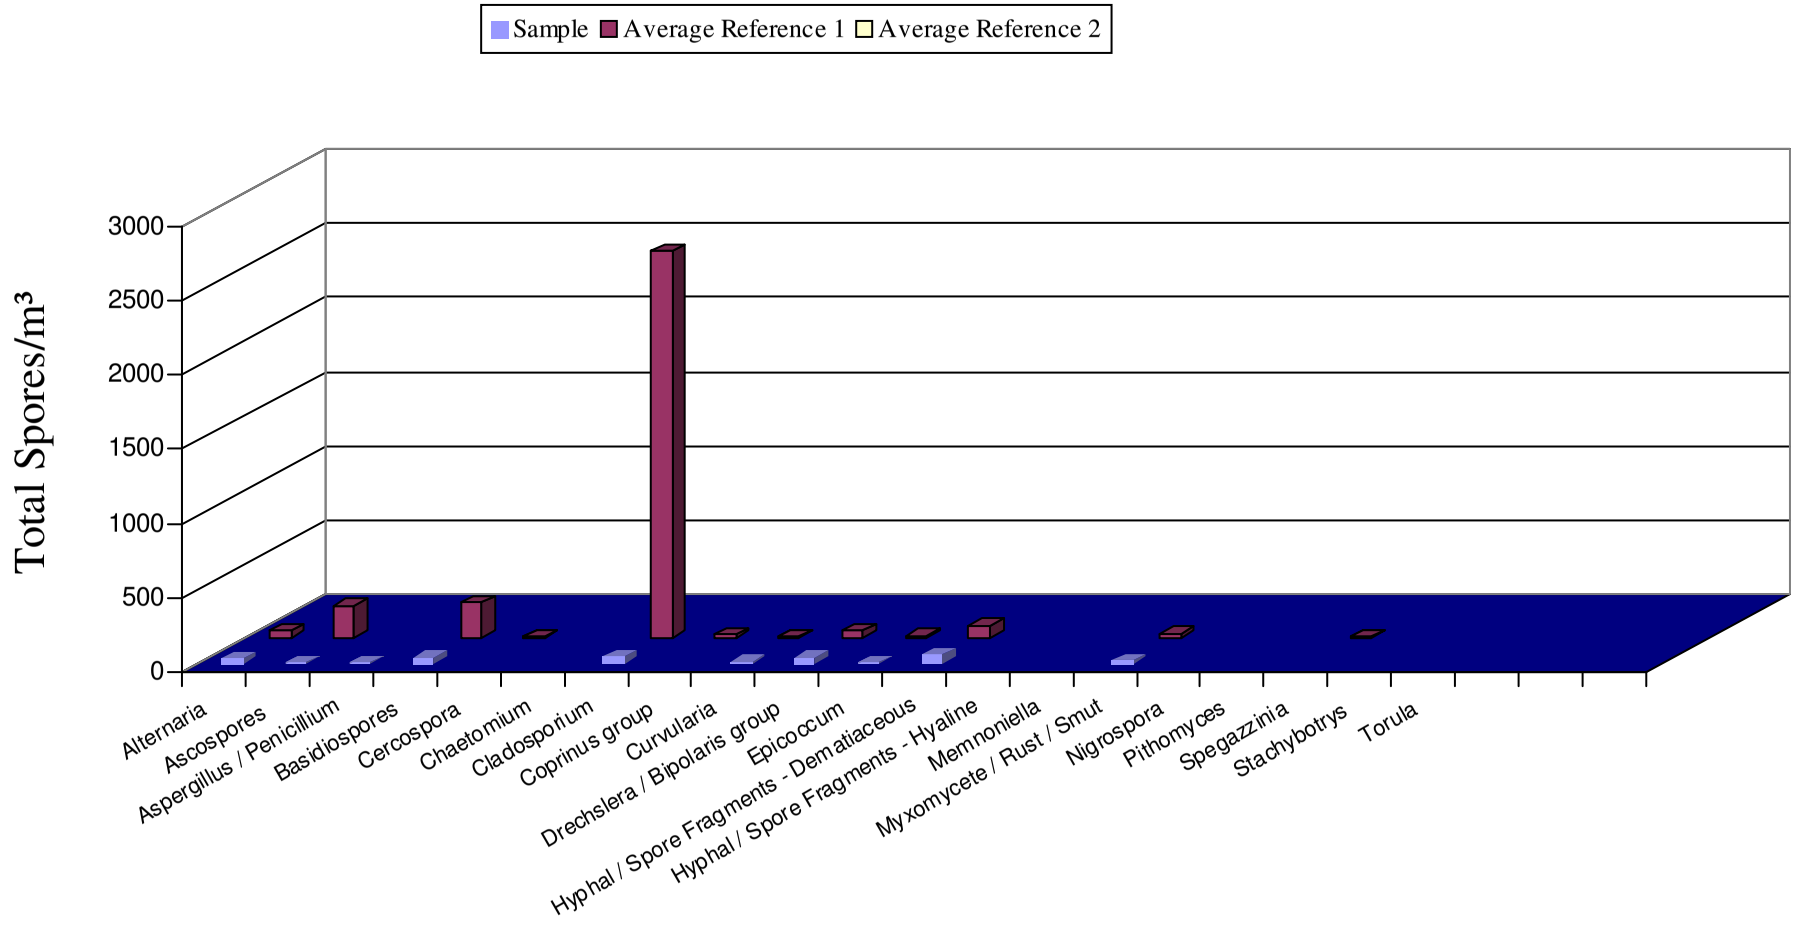
Two types of mold were identified at a higher concentration within the investigation area as compared to the samples collected from the exterior of the building. Air sample(s) collected within the Principal's Office reported Curvularia as 13 counts/m^3 while exterior levels were reported as 7 counts/m^3 and Aspergillus/Penicillium as 7 counts/m^3 while no exterior levels were reported.

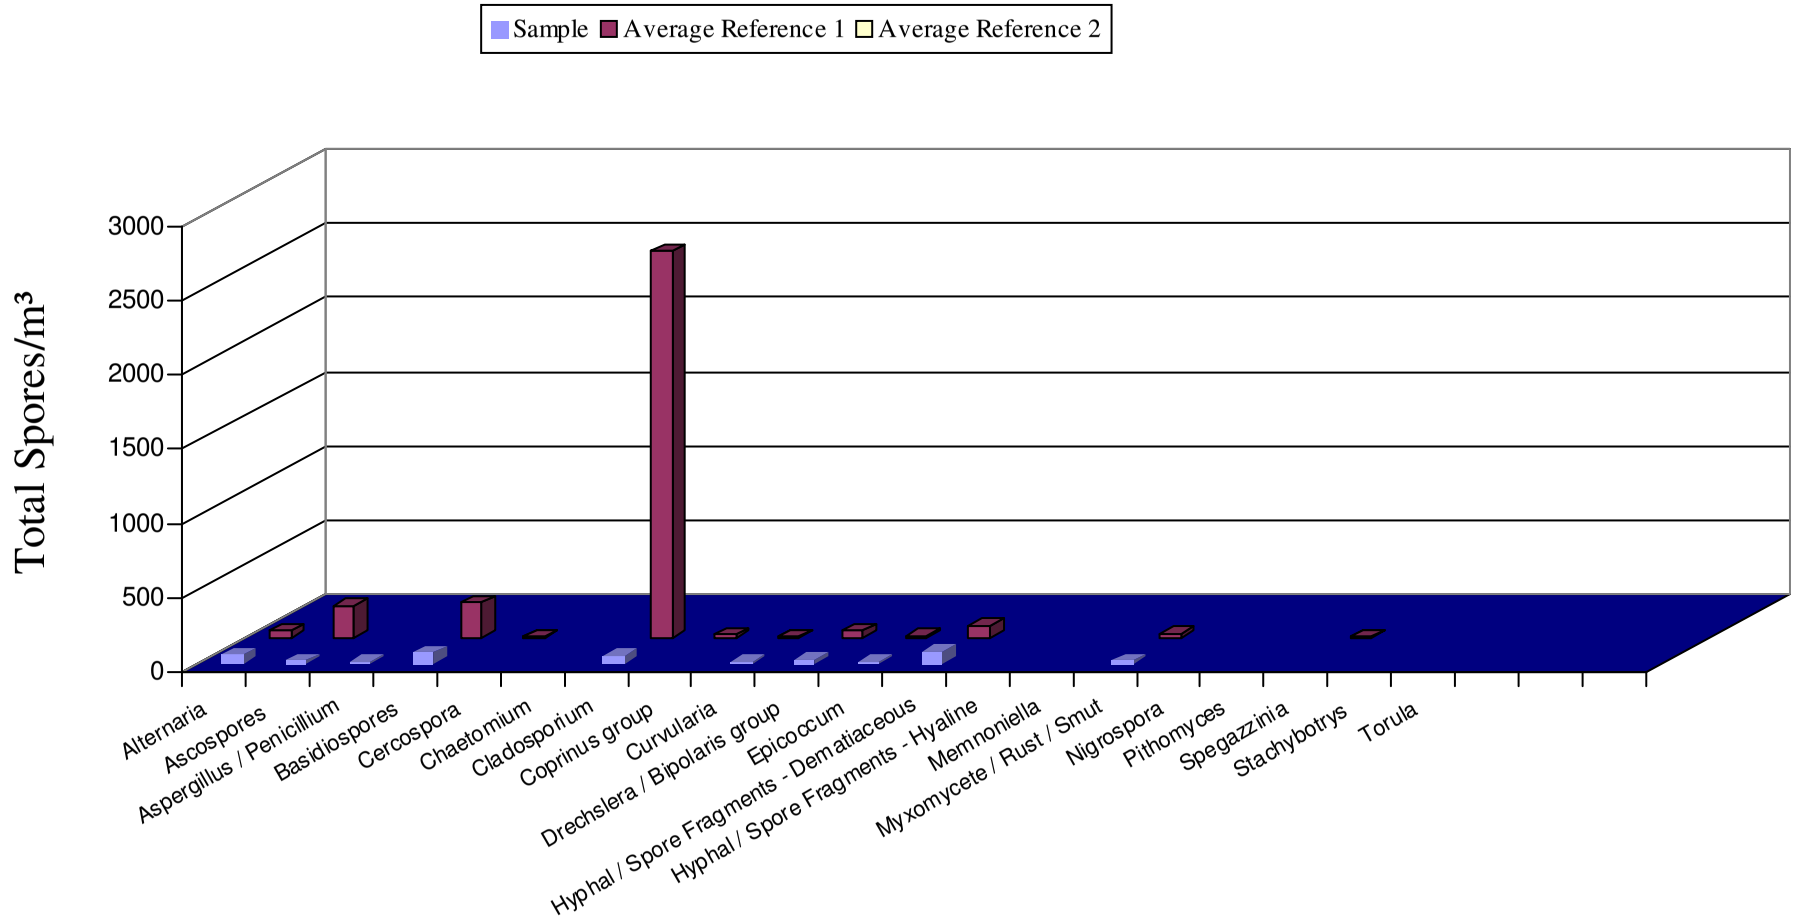
ART Room

Three types of mold were identified at a higher concentration within the investigation area as compared to the samples collected from the exterior of the building. Air sample(s) collected within the Art room reported Alternaria as 60 counts/m^3 while exterior levels were reported as 47 counts/m^3, Curvularia as 13 counts/m^3 while exterior levels were reported as 7 counts/m^3 and Aspergillus/Penicillium as 7 counts/m^3 while no exterior levels were reported.
