Flower Mound Elementary Limited Mold Assessment Room 144

Re: Limited Mold Assessment Report
Flower Mound Elementary School – Room 144
4101 Churchill Drive
Flower Mound, Texas 75028
LISD: CP 2561-18
Ensolum Project No. 01A1288200

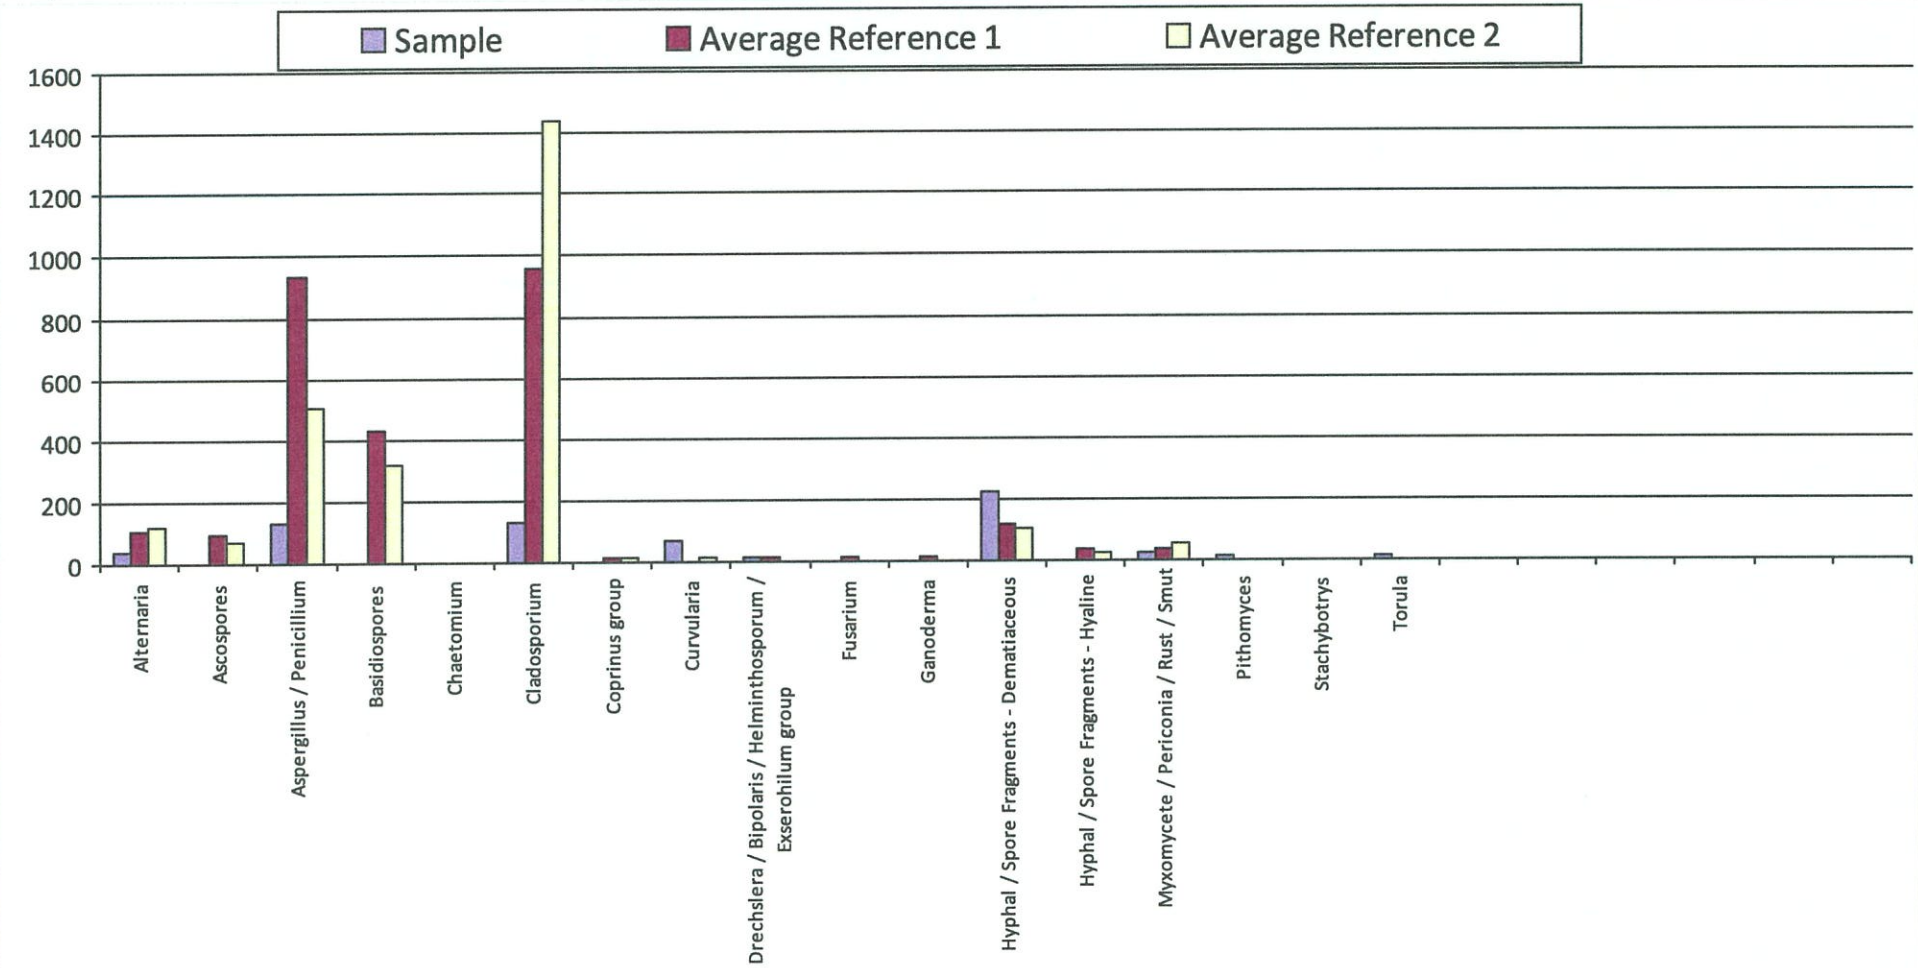
The results of the fungal air samples collected were evaluated. Air testing performed using spore traps found that total airborne mold spores within Classroom 144 were lower and qualitatively similar to those measured outside of the building at the time the sampling was performed. However, air testing found that some individual airborne mold spores within the room were elevated compared to the outdoor samples.

Based on ENSOLUM's limited assessment and the analytical results, it appears that the indoor air quality was within industry guidelines on the day of the assessment. However due to the elevated presence of Hyphal Spore Fragments compared to the exterior samples, Ensolum recommends that the investigation area be cleaned, and retesting be considered.
