SUBJECT: Garden Ridge ES - IAQ - Air Test - Room 214

SUBJECT: Garden Ridge ES - IAQ - Air Test results - Room 214

Re: Limited Mold Assessment Services
Garden Ridge Elementary School
Room 214
2220 S. Garden Ridge Boulevard
Flower Mound, Texas
LISD PO No. 91536213-00
Apex Project No. 7250115170

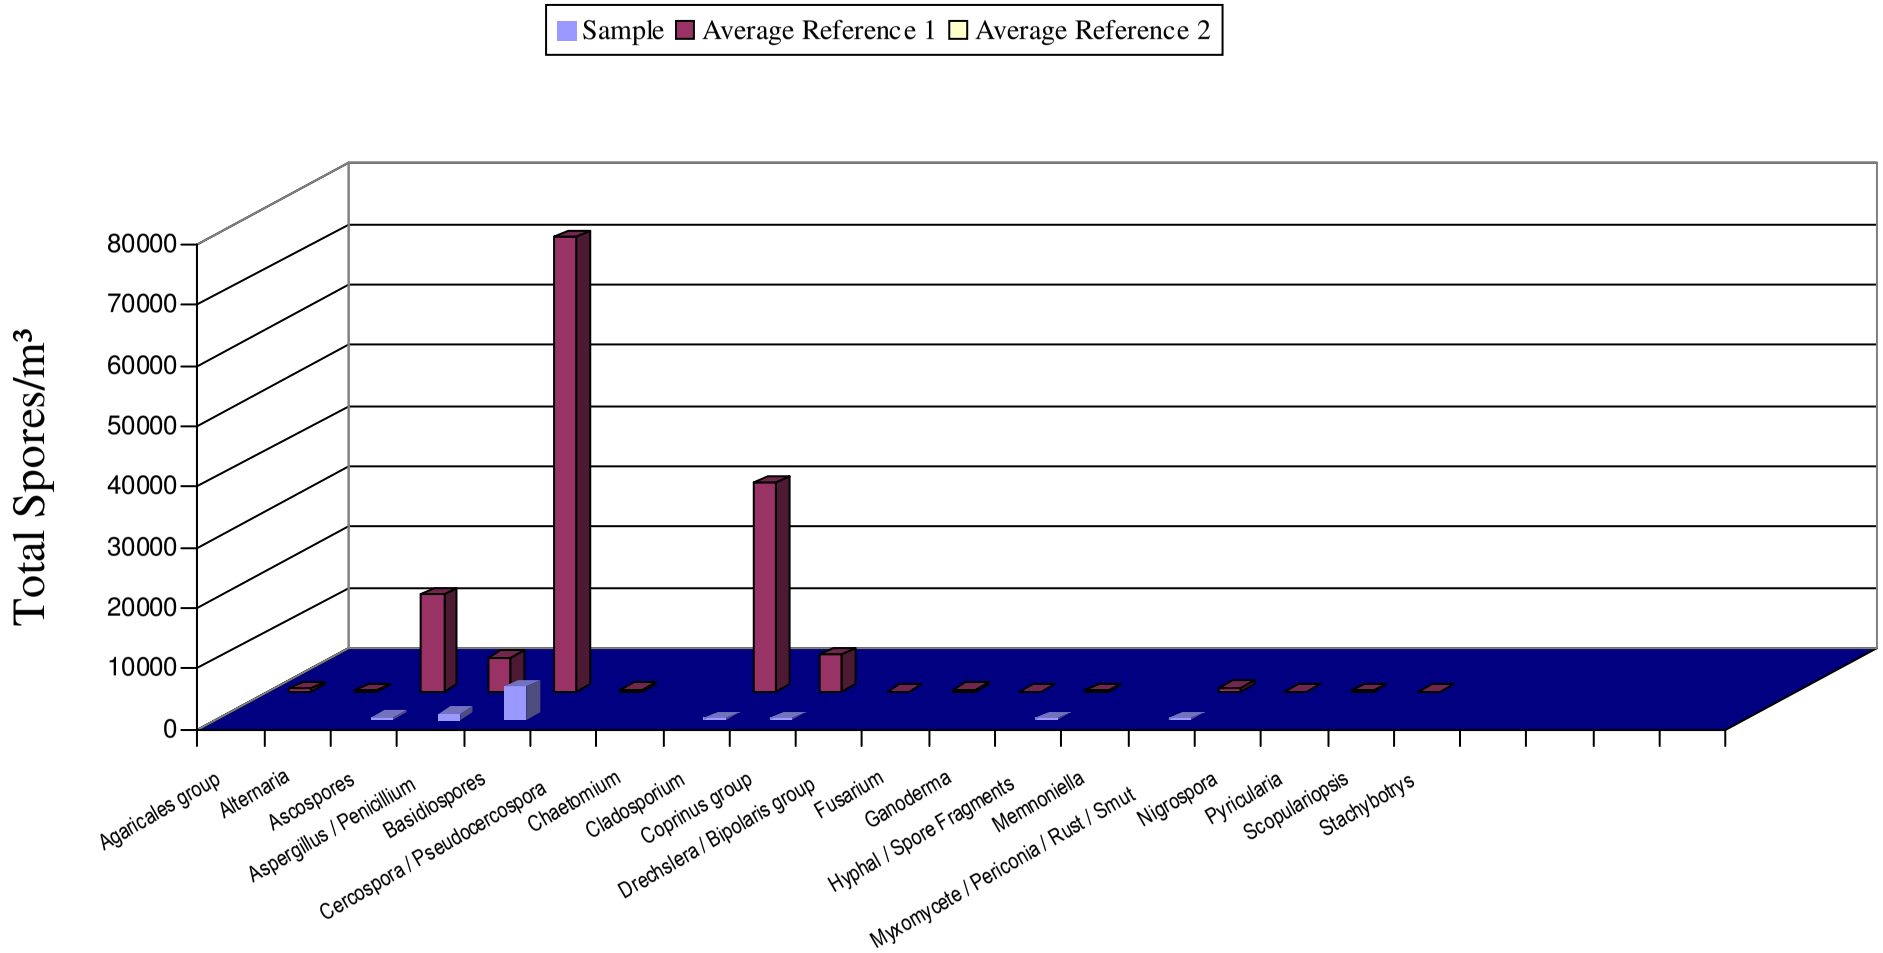
Room 214

Air testing performed using spore traps indicated that total airborne mold spores in the classroom were lower as compared to those measured outside of the building at the time the sampling was performed. The total fungal spore concentration within the investigation area was reported as 6,746 counts/m^3, while the exterior level ranged from 123,679 to 156,626 counts/m^3.

Based on Apex's limited assessment and the analytical results collected, it appears that the indoor air quality, as it relates to airborne fungi was within recommended guidelines on the day of the assessment.
