SUBJECT: Lamar MS - IAQ - Initial Contact - Outside Weight Room Building

SUBJECT: Lamar MS - IAQ - Air Test results - Outside Weight room

Re: Limited Mold Assessment Services
Lamar Middle School
Exterior Weight Room
4000 Timber Creek Road
Flower Mound, Texas
LISD PO No. 91533041-00
Apex Proposal No. 7250115148

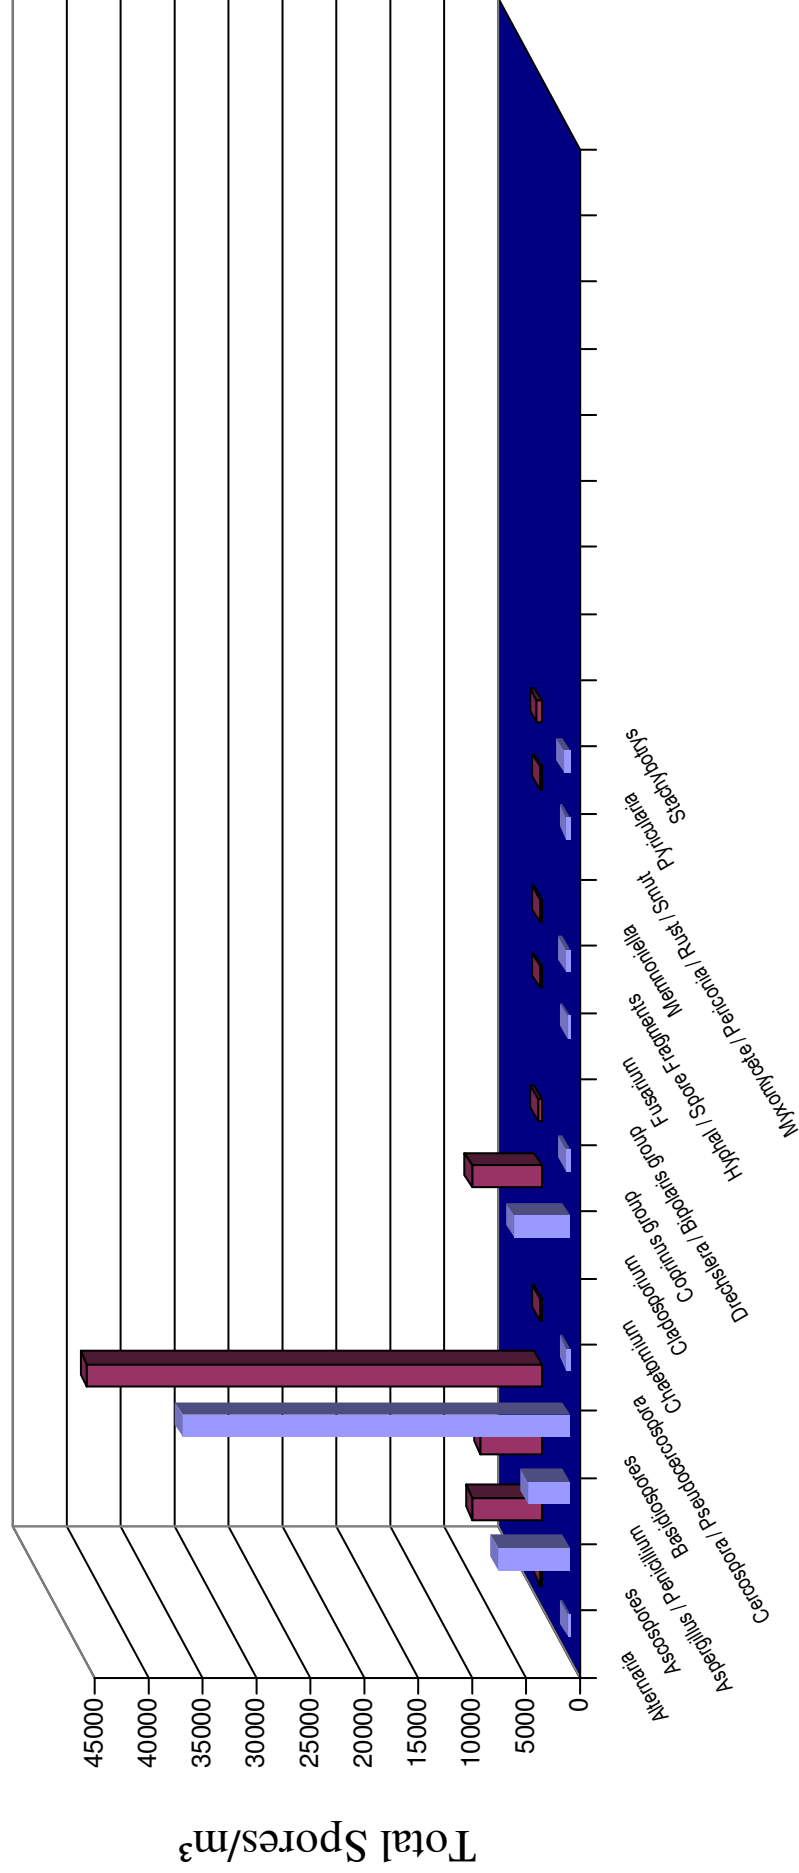
Client : Apex TITAN, Inc. - Dallas, TX
 Project : Lamar MS, Outside Weight Room
 Project # : 7250115148
 Exterior, South Side of School Bld.

Average Reference 1 = Exterior, South Side of School Bld., Exterior, North Side of Weight Rm Bld.

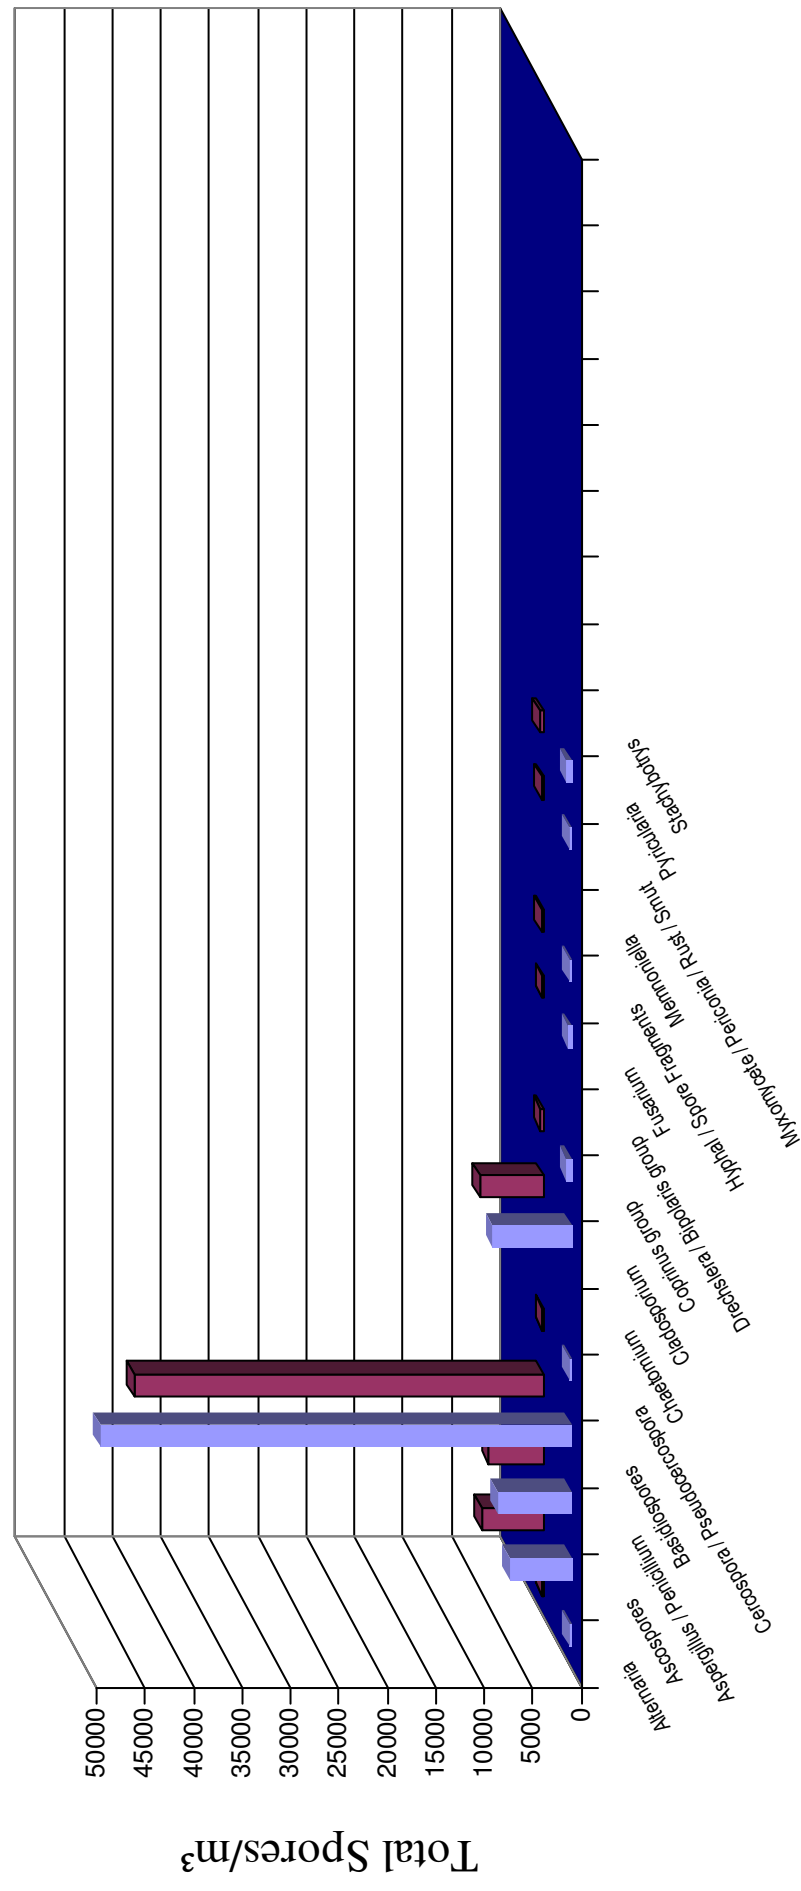
Average Reference 1 = Exterior, South Side of School Bld., Exterior, North Side of Weight Rm Bld.

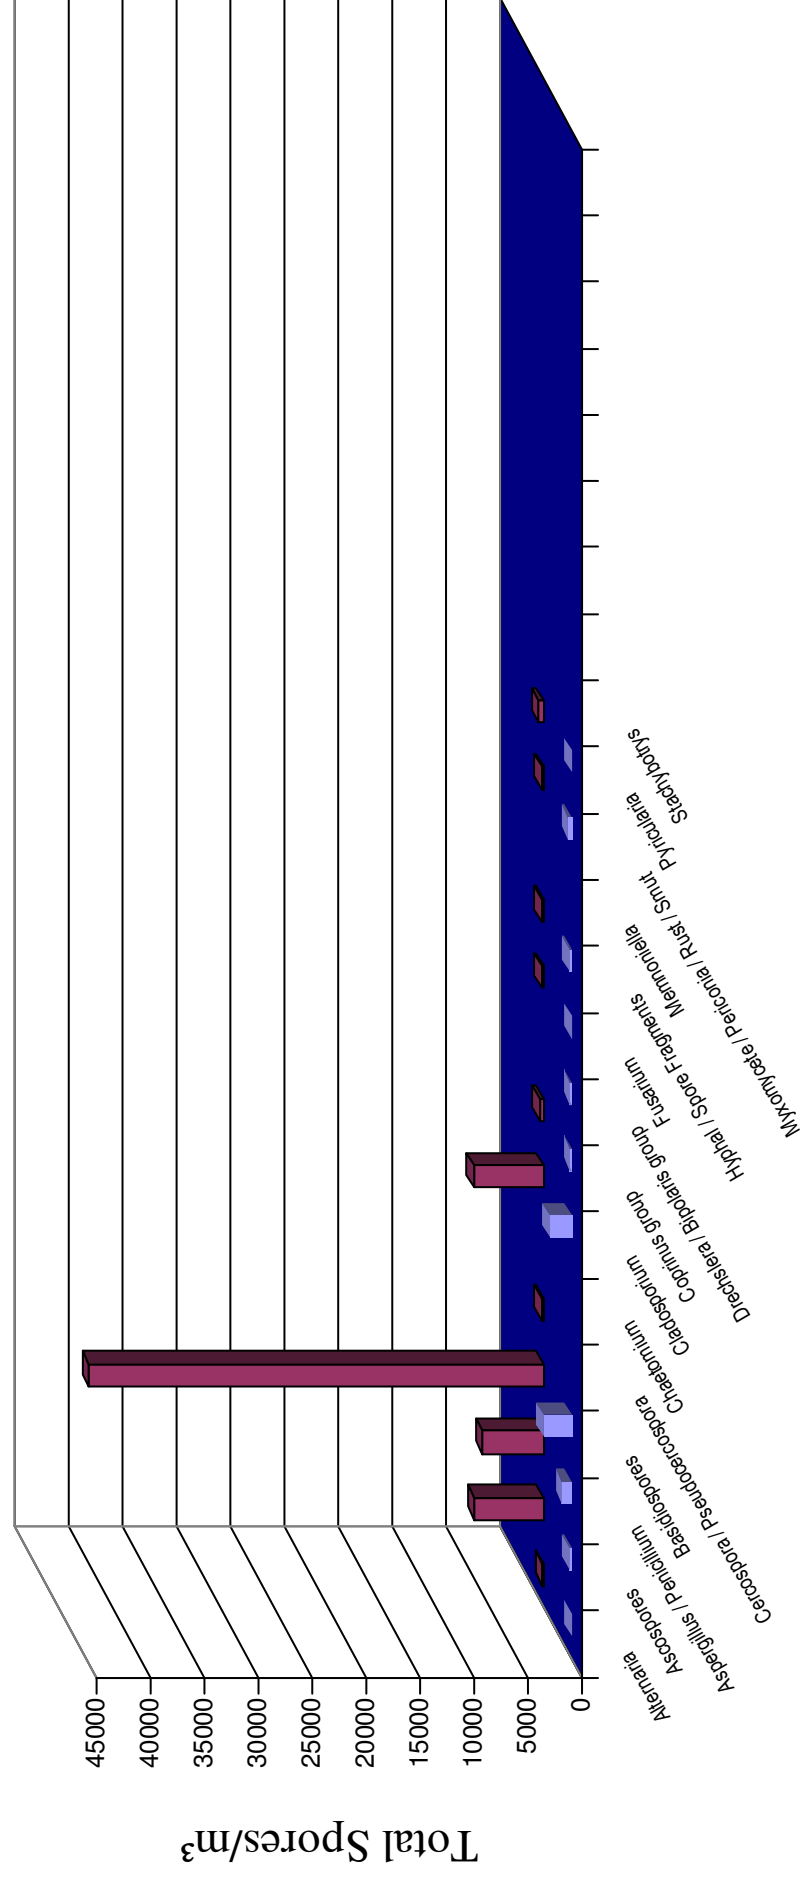
Outside Weight Room

Two types of mold were identified at a higher concentration within the investigation area as compared to the sample collected from the exterior of the building. Air sample(s) collected within the room reported Myxomycete/Periconia/Rust/Smut as 247 counts/m³ while exterior levels were reported as 227 counts/ m³ and Drechslera/Bipolaris group was reported as 13 counts/m³ while no exterior levels were reported.

Average Reference 1 = Exterior, South Side of School Bld., Exterior, North Side of Weight Rm Bld.

Based on Apex's limited assessment and the analytical results collected, it appears that the indoor air quality, as it relates to airborne fungi was within recommended guidelines on the day of the assessment.
